Manhole Inspection Summary

Manhole # S31GG2025MH

Insp Date: **12/20/06 2:35 PM**

Location Address: **5818 MEADOWOOD RD**

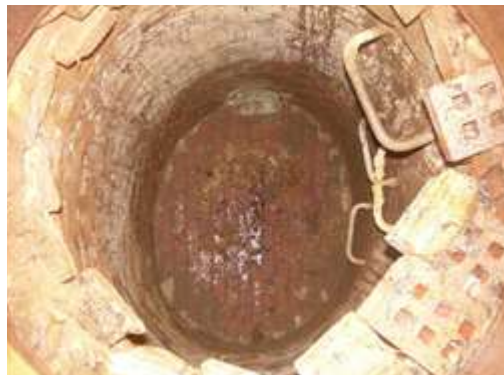
Top View

Channel debris.

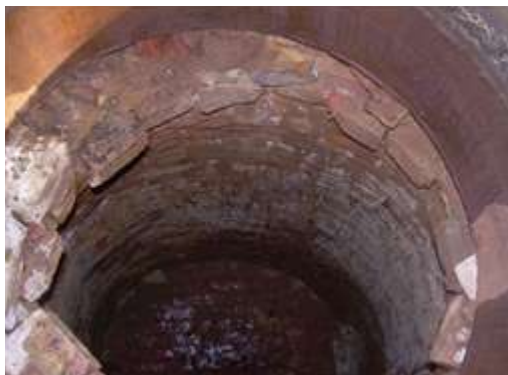
Defect

Frame offset. Adjustment deterioration, loose brick, and infiltration. Corbel and Barrel infiltration - other side.

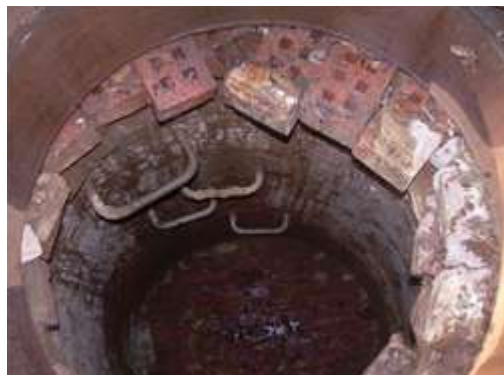
Defect

Frame offset. Adjustment deterioration, loose brick, and infiltration. Corbel and Barrel infiltration.

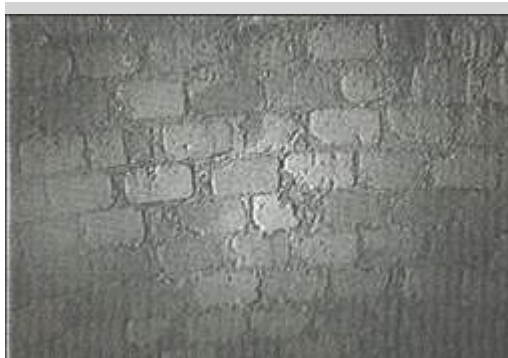
Defect

Barrel deterioration and infiltration.

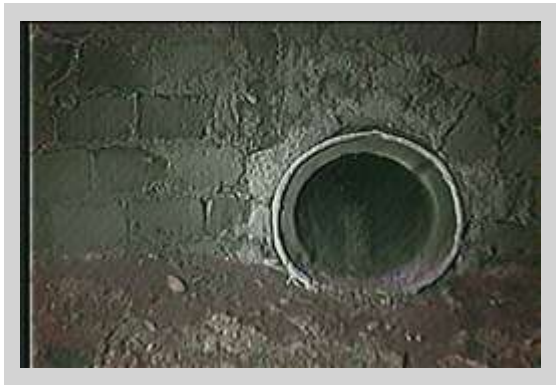
8 in. Circular Gravity Sewer
Pipe Out @ 12 O'Clock

Infiltration: **None** Pipe Seal Cond: **Cracked**
